# Application Focus

## Abrasive Attack - *Rotating Equipment*

# Application Case Study

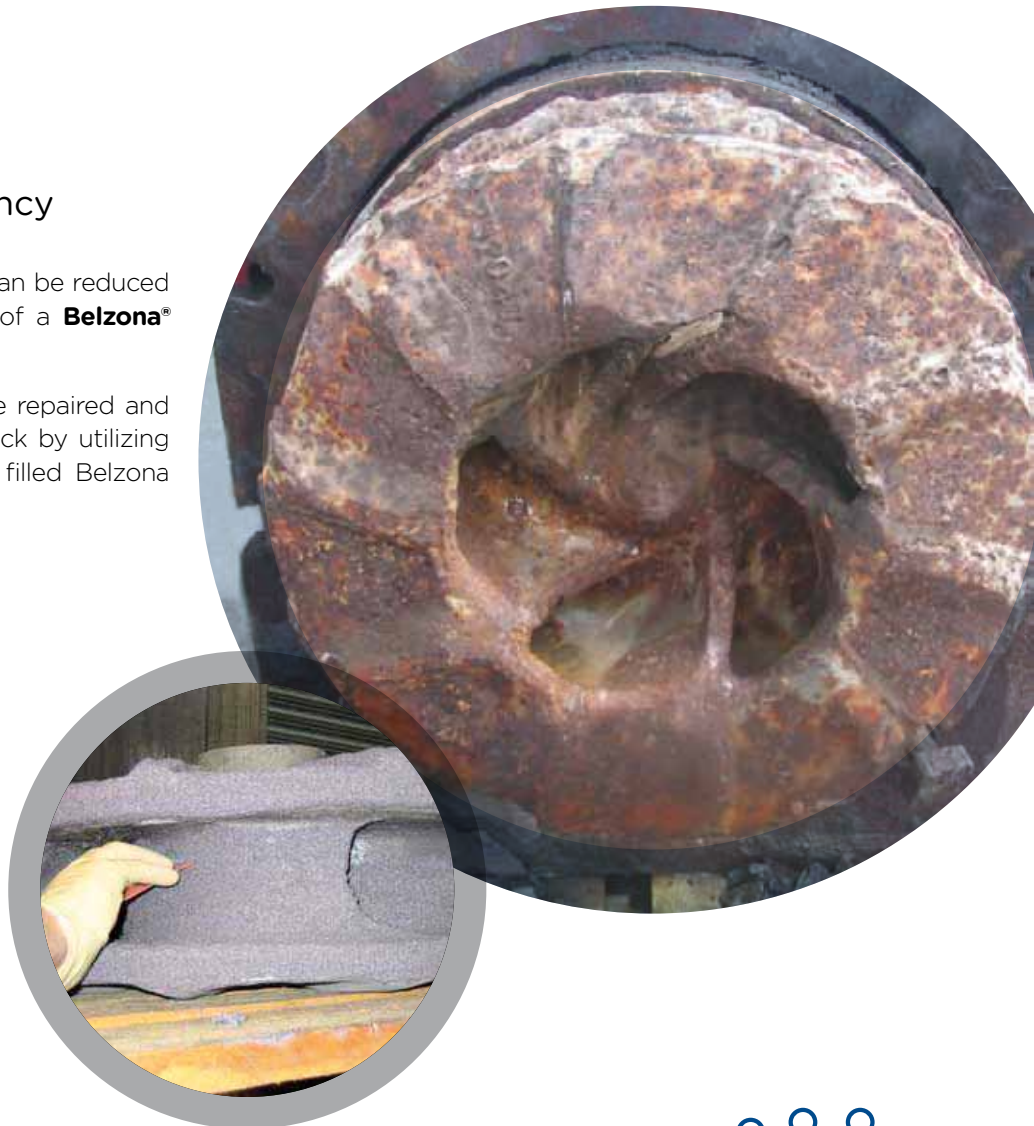
“A routine maintenance inspection of a centrifugal pump handling highly abrasive fly ash sludge was found to have severe erosion damage to its impeller and casing. Following further inspection, the impeller had approximately 10-15mm missing from the leading edge and the volute casing had cavities approximately 20mm in depth.”

The component parts were rebuilt with a Belzona composite repair system back to the original profile and machined with diamond cutting tips. The impeller and volute case were coated with a ceramic filled Belzona material, combining extremely hard, closely packed abrasion resistant materials in a polymeric binder in order to resist future abrasive attack.
